## East side listserv: March 6, 2020

### Notice of East Side Noise Fence Installation

Along Gore Rd. from Point St. Mark to Hwy 15

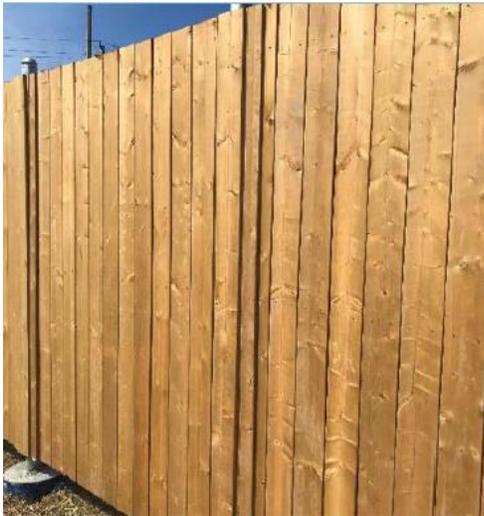
Photo: An image of the noise fence on the west shore installed in the fall. The east shore noise fence will look similar to this noise fence when complete.

outs. The noise wall will be finalized in the next couple of weeks and will be similar to the image below.
